# Alternative Fuel Tanks for Pickups with Sidesaddle Tanks

**Kennerly Digges**

Automotive Safety Research Institute

Copyright © 2005 SAE International

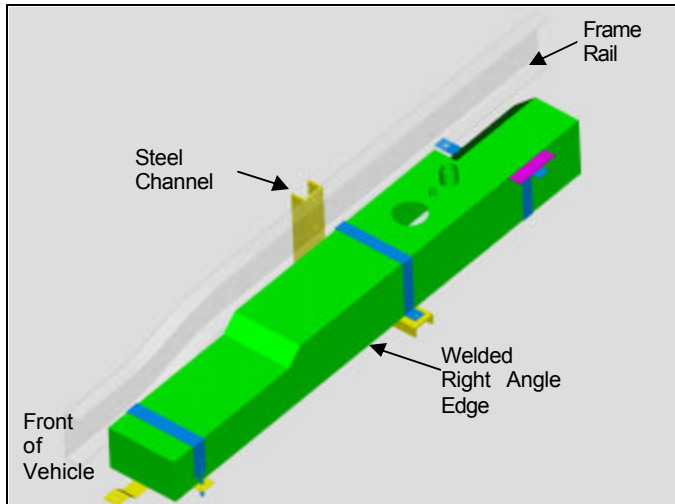
significant was the elimination of the welded seams for the bottom tank plate. Severe crimping occurred at the corner seams in Test 038, resulting in a small leak.

Figure 8. Early configuration of center-mounted tank and supports.

From the fourth test (039) onwards, the tank was modified so that the bottom and two sides were formed from a single plate. A 25.4 mm radius to the lower longitudinal edges of the tank was maintained. The purpose of the radius was to reduce localized stress resulting from folding a right angle edge in on itself when loaded. Additionally, the material for the middle bracket was changed from steel channel with right angle edges to steel tubing with rounded and thus less aggressive edges. Loading on the tank from these brackets would therefore be more evenly distributed, decreasing the possibility of tearing of the tank from concentrated edge loads from the brackets. The resulting design is shown in Figure 9.

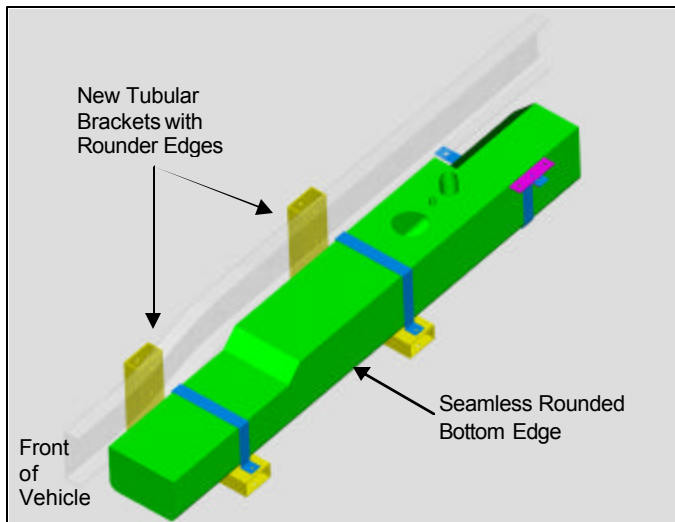
Figure 9. Modifications to improve side-impact protection.

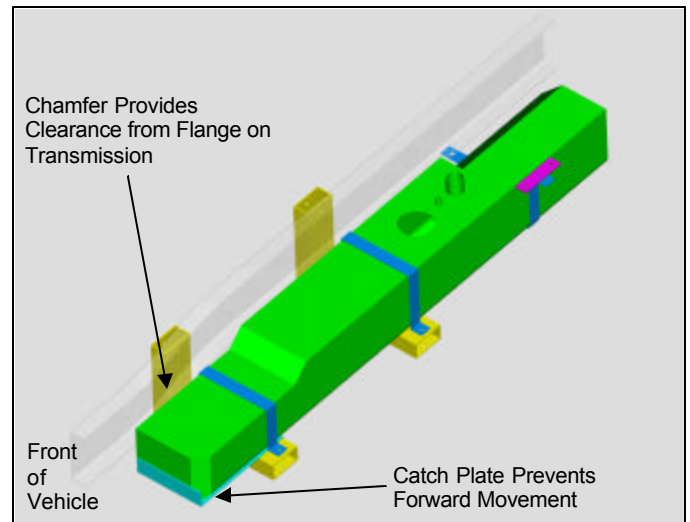
In addition, it was observed that the transmission moved rearward during a severe frontal crash. One of the transmissions available in the pickups contained a flange that could cause a stress concentration if it impacted the tank corner. To address this possibility, the tank corner closest to the transmission was modified to include a flattened region as shown in Figure 10.

Figure 10. Modifications to Improve frontal- impact protection

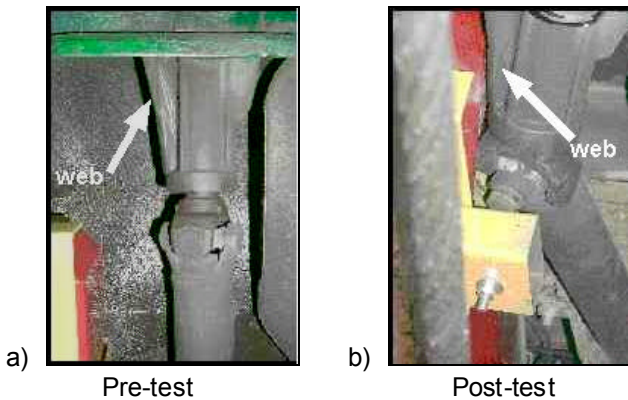
Relocating the tank between the frame rails reduces its vulnerability to side impact, but may increase vulnerability in some other crashes. In severe crashes into a rigid frontal barrier the engine and transmission move rearward. An aggressive web on one of the alternative transmission produced a leak in one frontal barrier test. In addition, the drive shaft may buckle in the direction of the tank causing damage. Figure 11 shows the location of the aggressive transmission web and the drive shaft relative to the tank before and after a frontal crash test.

Figure 11. Drive shaft and transmission clearance in severe frontal crash – before (a) and after (b).

The final center-mounted tank design addressed both of these undesirable loadings. The transmission contact was mitigated by increasing the tank to transmission clearance and by chamfering the corner of the tank to reduce the stress concentration when contact occurs. The drive shaft contact was addressed by maintaining OEM drive shaft clearance for center-mounted tanks and by positioning the tank brackets to resist drive shaft loading. The tank thickness of 1.52 mm provided added protection compared with 0.86 mm in the OEM tank.

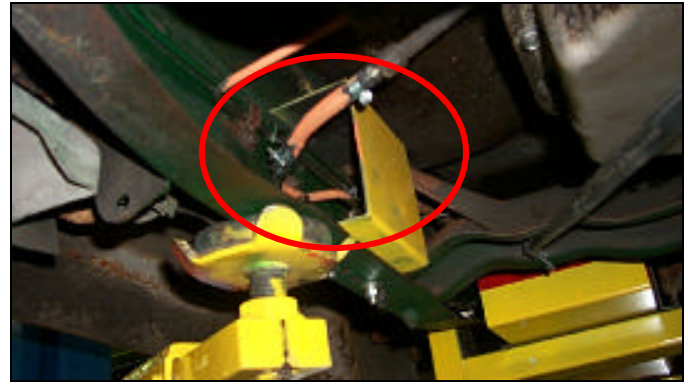
The Caprice impact produced extensive deformation to the pickup frame. In some cases, the fuel lines and/or fuel tank selector valves were severed by being pressed between the inside of the frame and the engine. This problem was aggravated in one test in which the exhaust manifold had been removed. In that test, the fuel line was severed when entrapped between the frame and a flange on the transmission. To improve the survivability of fuel lines, a structural shield was added inside the frame to protect the fuel filter. The shield is shown in Figure 12. No fuel line ruptures occurred on tests with the shielding in place.

Figure 12. Shielding plate to protect fuel lines from entrapment by the transmission.

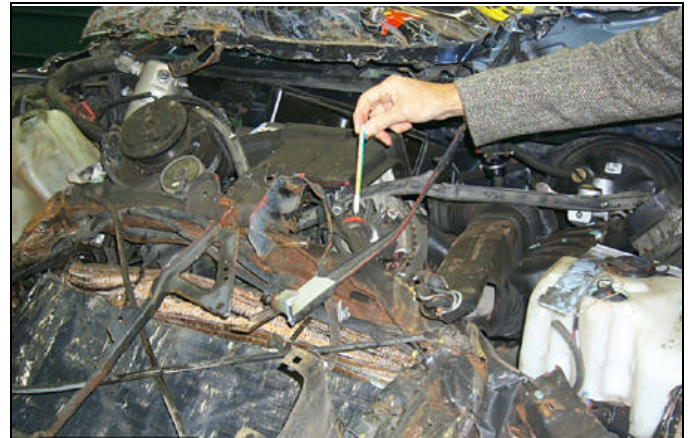
It was found that the front hood of the bullet Caprice was peeled away in the side impact tests. As a result, many sharp edges were exposed. In addition, the battery, electrical wiring, and hot engine surfaces were exposed providing possible ignition sources. Figure 13 shows the protruding alternator and other sharp edges that scraped the bottom of the pickup tank in a crash test. For the center-mounted tank, the hard points resulted in scragging and minor gouging of the tanks. However, no leakage occurred from this source in any tests of the center-mounted tank.

Figure 13. Caprice engine compartment after test showing hard points that contacted the fuel tank.
